**Flood Control Project Maintenance  
Levee Inspections**

**Maintenance Issue Types Only, Levee Inspection Report By Mile - Fall 2019**

**Sutter Maintenance Yard Maintenance Area 0005**

Waterway	Bank	Unit Miles	Inspection Start/End	Inspector
Unit No. 01 Butte Creek	Left	15.08	10/23/2019 10/23/2019	Makar Sokol

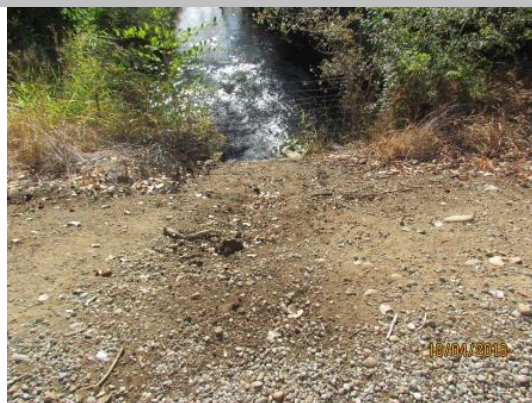
Photo 1 of 1 : FA\_2019\_MA0005\_196\_46\_20190822\_00022.jpg

LM Start	0.07	Rating **	M	Issue No.	46
LM End	0.07	Issue Type +	Ma	Location *	LS
Category	Earthen Levee			GPS Latitude/Longitude	
				Start	End
Item	Slope Stability			39.696611 °	39.696611 °
				-121.774349 °	-121.774349 °
DWR ID	DWR_MA0005_01_f_2016_46				
Comment Code					
S2 : Repair the levee slope damaged by foot traffic and prevent access where possible.					
Inspector Comment

View of the damaged slope by foot traffic.

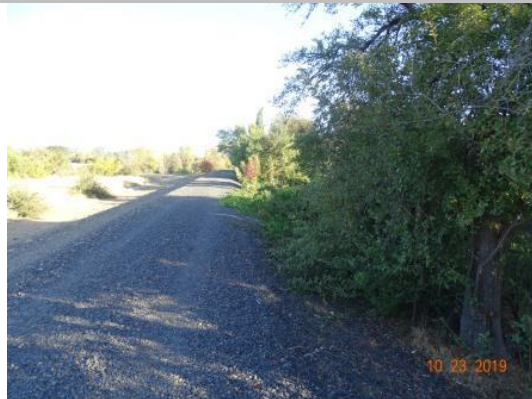
Photo 1 of 1 : FA\_2019\_MA0005\_196\_47\_20191028\_00086.jpg

View of trees that require trimming along the landside slope. Fall 2019.

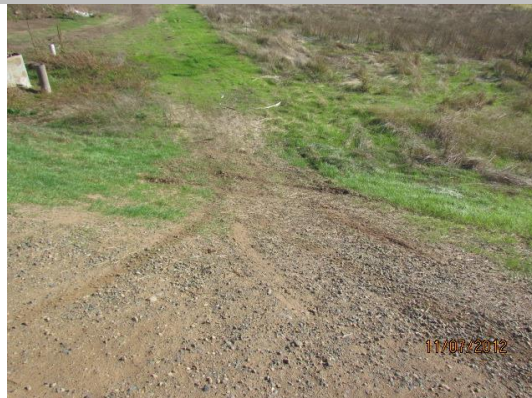
Photo 1 of 1 : FA\_2019\_MA0005\_196\_9\_20190822\_00004.jpg

LM Start	2.54	Rating **	M	Issue No.	9
LM End	2.54	Issue Type +	Ma	Location *	LS
Category	Earthen Levee			GPS Latitude/Longitude	
				Start	End
Item	Slope Stability			39.663876 °	39.663876 °
				-121.784014 °	-121.784014 °
DWR ID	DWR_MA0005_01_f_2012_9				
Comment Code					
S3 : Repair the levee slope damaged by vehicle traffic and prevent access where possible.					
Inspector Comment

View of the vehicle erosion along the landside slope.

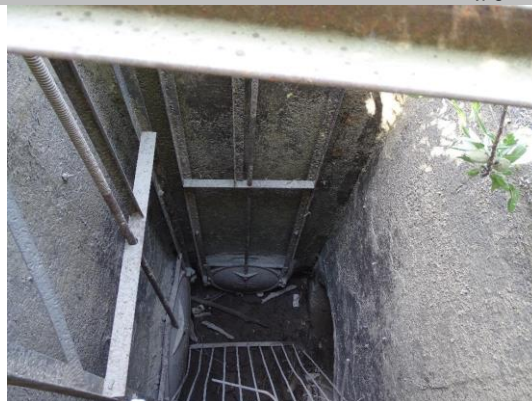
Photo 2 of 3 : UCIP\_FA\_2019\_54141\_79696.jpg

View inside of concrete distribution box on LS

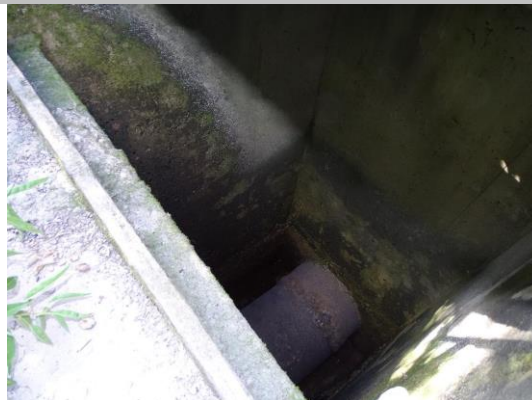
Photo 3 of 3 : UCIP\_FA\_2019\_54141\_79699.jpg

Steel welded pipe inside of concrete distribution box on LS goes toward the levee

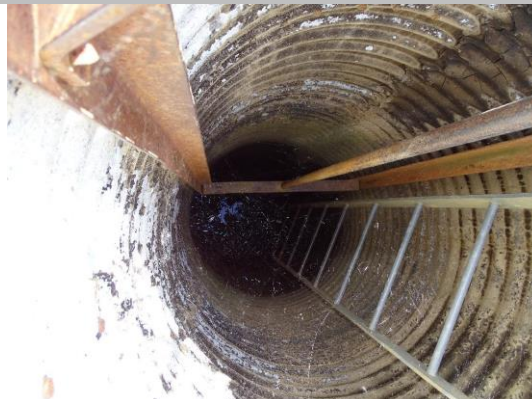
Photo 2 of 3 : UCIP\_FA\_2019\_54142\_79703.jpg

Inside view of CMP riser on WS shoulder

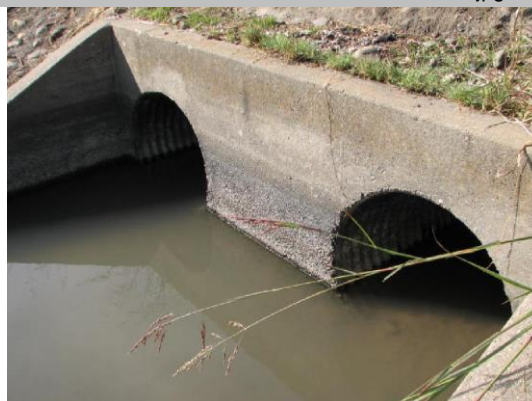
Photo 1 of 2 : UCIP\_FA\_2019\_54040\_67941.jpg

Comment Code						
Inspector Comment						
DS_ID:1620 FS_ID:54040 EP_NO: N/A Repair Type: Non-Urgent Crossing Status: Found UCIP Comments: 05/23/2019 (O. Magana - DWR UCIP)05/15/2017 Abandoned and needs to be done properly. A sink hole formed in the WS toe road and revealed the location of the WS pipe end. Sink hole will ned to be repaired before the next high water season but the pipe has been selected to be internally cleaned and camera inspected as part of the DMP project so it will have needed to be excavated along the WS end anyways. (DWR Sutter Yard- AFreitag)11/15/2016 Abandoned. Needs cover for the standpipe. (DWR Sutter Yard- AFreitag)05/09/2016 Abandoned pipe. Needs a cover for the standpipe.08/05/2015 Abandoned crossing. Covers need to be made for tops of standpipes to prevent falls.12/08/2014 Same as last inspection.06/11/2014 Same as last inspection.11/19/2013 Same as last inspection.05/29/2013 Same as last inspection. Land owner said pipes are abandoned and no longer used. Covers should be made for top of standpipe to prevent falls. Pipes should be properly abandoned.10/30/2012 Pipe 1/2 filled with soil at slide gate end. FIELD_STRUCT_DESC: *ABANDONED* 1 of 2: 36-inch drainage pipe through the levee, 11 feet below the crown. Slide gate in a 54-inch corrugated metal riser on the waterside (WS) slope. Concrete "U" headwall on the landside (LS). [Additional Reference(s): DWR Levee Log, 1990 (HLM 5.66). Sacramento O&M Manual, Unit 516 - Upper Butte Creek - Part No. 2, April 1960 (Station 470+00)]. FS Date: 5/23/2019 5:10:38 PM

Headwall at LS toe.

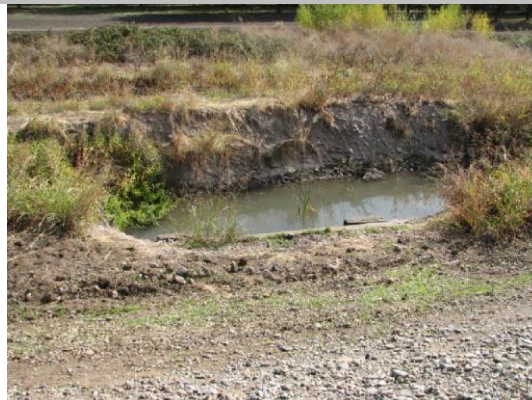
Photo 1 of 3 : UCIP\_FA\_2019\_54039\_67939.jpg

Comment Code						
Inspector Comment						
DS_ID:1768 FS_ID:54039 EP_NO: N/A Repair Type: Non-Urgent Crossing Status: Found UCIP Comments: 05/23/2019 (O. Magana - DWR UCIP)05/15/2017 Abandoned and needs to be done properly. A sink hole formed in the WS toe road and revealed the location of the WS pipe end. Sink hole will ned to be repaired before the next high water season but the pipe has been selected to be internally cleaned and camera inspected as part of the DMP project so it will have needed to be excavated along the WS end anyways. (DWR Sutter Yard- AFreitag)11/15/2016 Abandoned. Needs standpipe cover. (DWR Sutter Yard- AFreitag)05/09/2016 Abandoned pipe. Needs a cover for standpipe.08/05/2015 Abandoned pipes. Need covers made for tops of standpipes to prevent falls. 12/08/2014 Same as last inspection.06/11/2014 Same as last inspection.11/19/2013 Same as last inspection.05/29/2013 Same as last inspection. Land owner said pipes are abandoned and no longer used. Covers should be made for top of standpipe to prevent falls. Pipes should be properly abandoned.10/30/2012 Pipe 1/2 filled with soil at slide gate on WS. FIELD_STRUCT_DESC: *ABANDONED* 2 of 2: 36-inch corrugated metal drainage pipe through the levee, 11 feet below the crown. Slide gate in a 54-inch corrugated metal riser on the waterside (WS) slope. Concrete "U" shaped headwall on the landside (LS). [Additional Reference(s): DWR Levee Log, 1990 (HLM 5.66). Sacramento O&M Manual, Unit 516 - Upper Butte Creek - Part No. 2, April 1960 (Station 470+00)]. FS Date: 5/23/2019 5:08:45 PM

Headwall at LS toe.

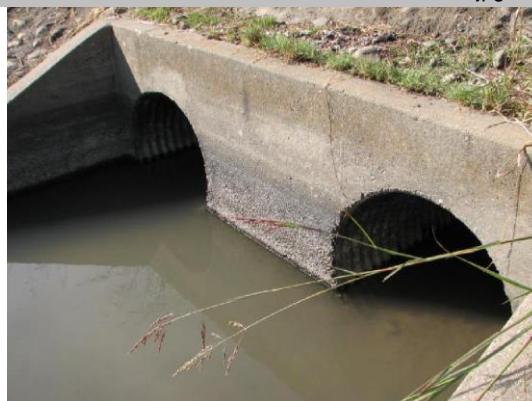
Photo 2 of 3 : UCIP\_FA\_2019\_54039\_67938.jpg

Headwall at LS toe.

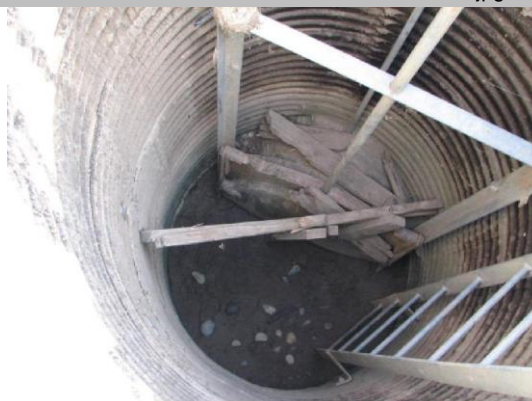
Photo 3 of 3 : UCIP\_FA\_2019\_54039\_67937.jpg

Slide gate at bottom of cmp riser.

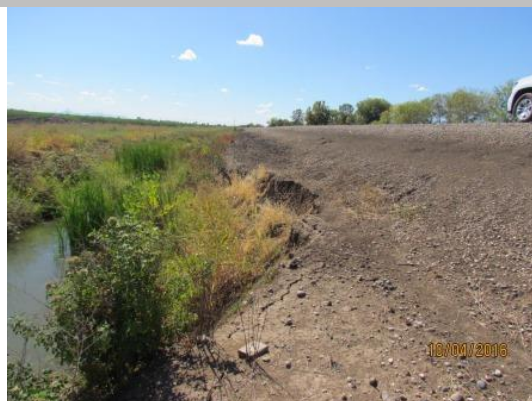
Photo 1 of 2 : FA\_2019\_MA0005\_196\_56\_20190822\_00027.jpg

LM Start	5.81	Rating **	U	Issue No.	56
LM End	5.81	Issue Type +	Ma	Location *	LS
Category	Earthen Levee			GPS Latitude/Longitude	
				Start	End
Item	Erosion / Bank Caving			39.621261 °	39.621261 °
				-121.773973 °	-121.773973 °
DWR ID	DWR_MA0005_01_f_2016_56				
Comment Code					
E2 : Schedule repair of erosion site prior to the next inspection.					
Inspector Comment

View of the landside toe erosion.

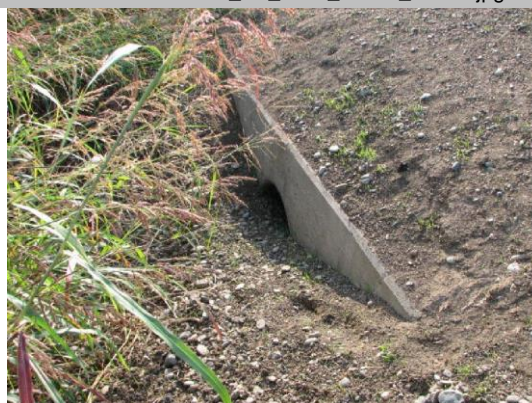
Photo 2 of 2 : UCIP\_FA\_2019\_51970\_67969.jpg

Headwall at LS toe.

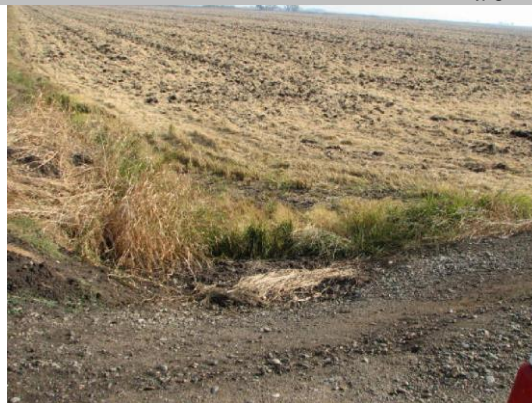
Photo 2 of 3 : UCIP\_FA\_2019\_51972\_67972.jpg

DS\_ID:1629  
FS\_ID:51972  
EP\_NO: N/A  
Repair Type: Non-Urgent  
Crossing Status: Found  
UCIP Comments: 5/16/2017 LS inlet is half blocked off by flash boards and sediment. WS flap gate is blocked closed by sediment. Pipe has been selected to be internally cleaned and inspected as part of the DMP project. (DWR Sutter Yard- AFreitag)11/15/2016 LS inlet was unburied and entire pipe is about 25% full of soil. WS flapgate was shut and partially buried. (DWR Sutter Yard- AFreitag)5/11/2016 WS flap gate was about 50% buried and LS was 100% buried. Appears to be an abandoned crossing.8/4/2015 WS flap gate is partially buried by soil and being overgrown with vegetation. LS pipe end was underwater and suspected to still be completely buried with soil.12/8/2014 Same as last inspection.6/11/2014 Same as last inspection.11/19/2013 Same as last inspection.5/29/2013 Same as last inspection.10/30/2012 Pipe filled with soil.

Buried inlet at LS toe.

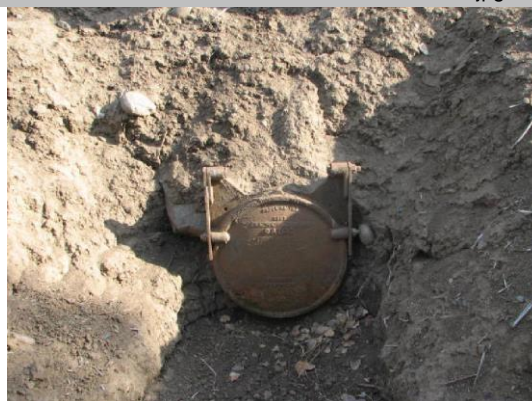
Photo 3 of 3 : UCIP\_FA\_2019\_51972\_67971.jpg

Flap gate at WS toe.

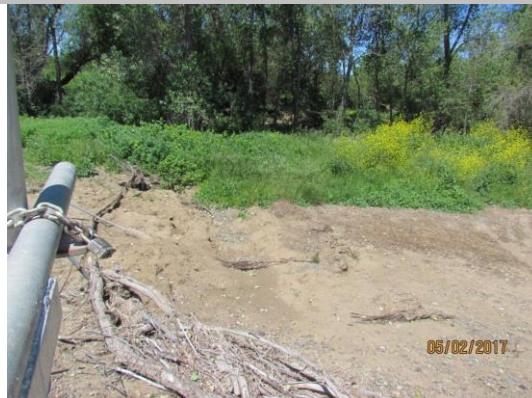
Photo 1 of 1 : FA\_2019\_MA0005\_196\_67\_20190822\_00030.jpg

View of erosion along the waterside slope.

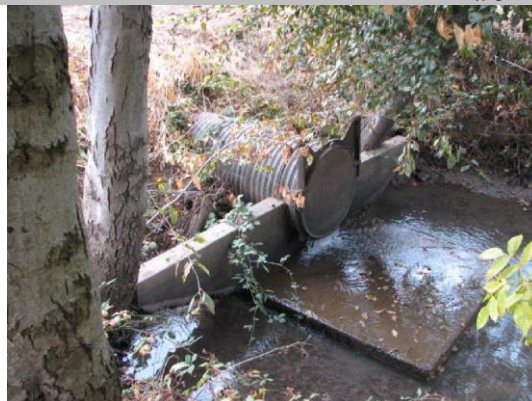
Photo 3 of 3 : UCIP\_FA\_2019\_51999\_68031.jpg

Wingwalls of headwall not supported by soil.

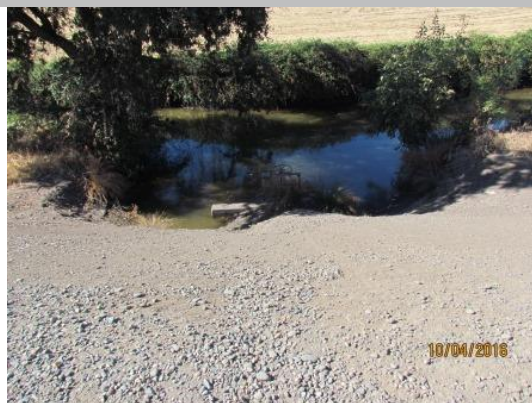
Photo 1 of 1 : FA\_2019\_MA0005\_197\_49\_20190822\_00024.jpg

View of the landside toe erosion.

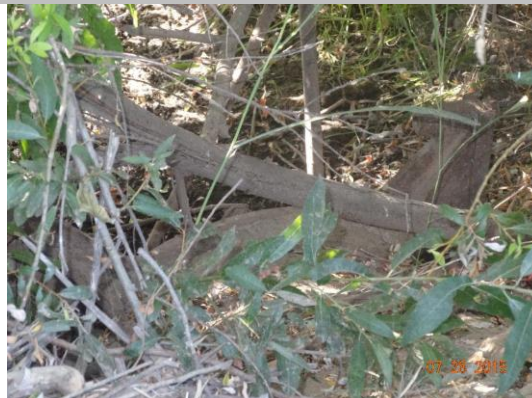
Photo 3 of 3 : UCIP\_FA\_2019\_53009\_74600.jpg

WS flap gate overgrown with vegetation.

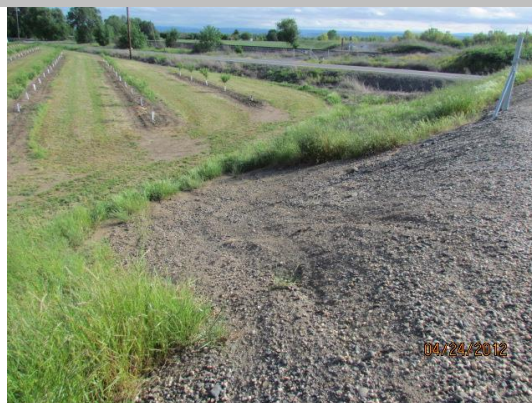
Photo 1 of 2 : FA\_2019\_MA0005\_197\_13\_20190822\_00006.jpg

View of the vehicle erosion along the slope.

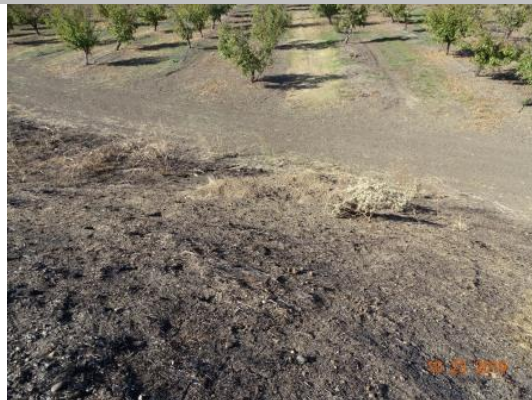
Photo 1 of 1 : FA\_2019\_MA0005\_197\_73\_20191028\_00101.jpg

View of two large rodent burrows on the landside slope and toe. Fall 2019.

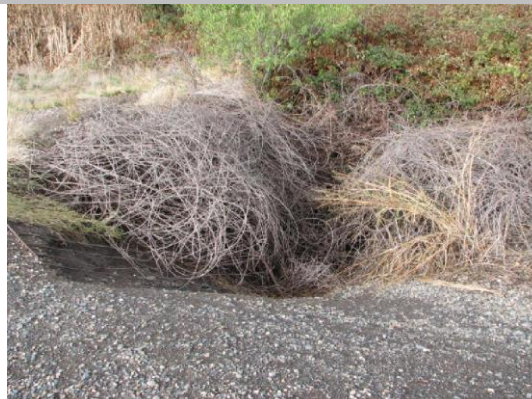
Photo 2 of 3 : UCIP\_FA\_2019\_52062\_68404.jpg

Brambles and soil over pipe at inlet.

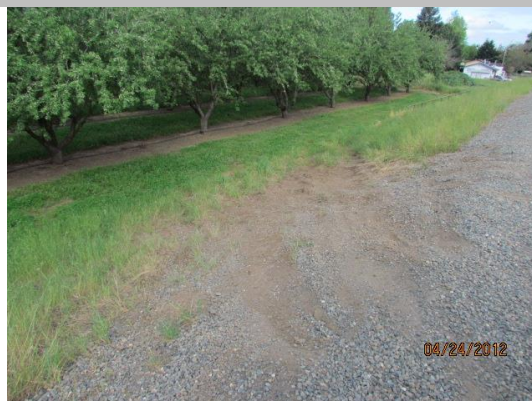
Photo 1 of 1 : FA\_2019\_MA0005\_197\_18\_20190822\_00008.jpg

View of the vehicle erosion along the slope of the levee.

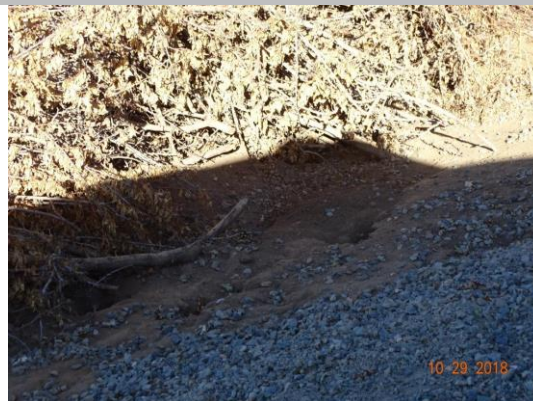
Photo 1 of 1 : FA\_2019\_MA0005\_197\_71\_20190822\_00036.jpg

View of the rodent holes along the landside slope.

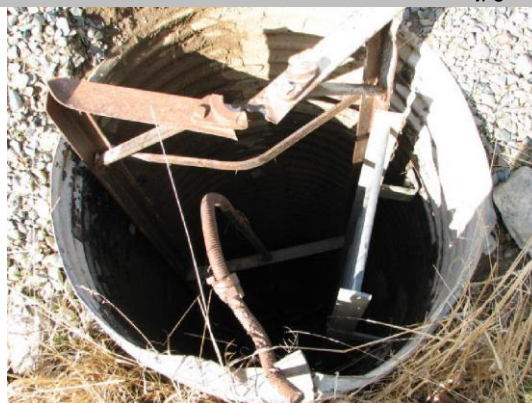
Photo 3 of 3 : UCIP\_FA\_2019\_54048\_68463.jpg

Broken slide gate in CM riser on WS slope.

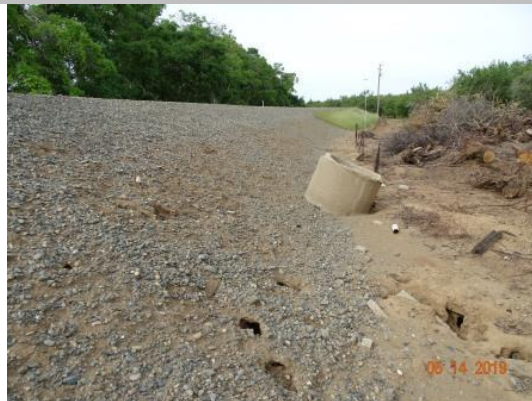
Photo 1 of 1 : FA\_2019\_MA0005\_197\_9\_20190822\_00005.jpg

View of the animal burrows on the landside slope. Spring 2019.

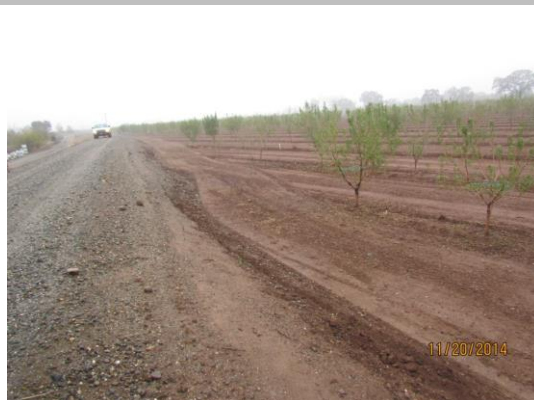
Photo 1 of 1 : FA\_2019\_MA0005\_197\_43\_20190822\_00019.jpg

View of the tilling into the landside slope.

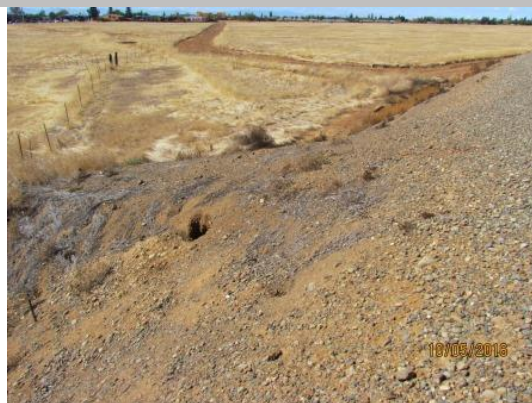
Photo 1 of 1 : FA\_2019\_MA0005\_197\_39\_20190822\_00015.jpg

View of the rodent holes along the landside slope.
